## **THE BLUFFS AT EVERGREEN FIRE INVESTIGATION REPORT**

Insured: DH&G LLC  
Loss Location: 2 West Casino Rd.  
Everett, WA 98204  
Date of Loss: December 31, 2015  
File Number: 220.19486  
JH File Number: 1C0703257

JENSEN HUGHES was retained on January 6, 2016 and requested to investigate the origin and cause of a December 31, 2015 fire at the Bluffs at Evergreen apartment complex, located at 2 West Casino Rd., Everett, WA 98204.

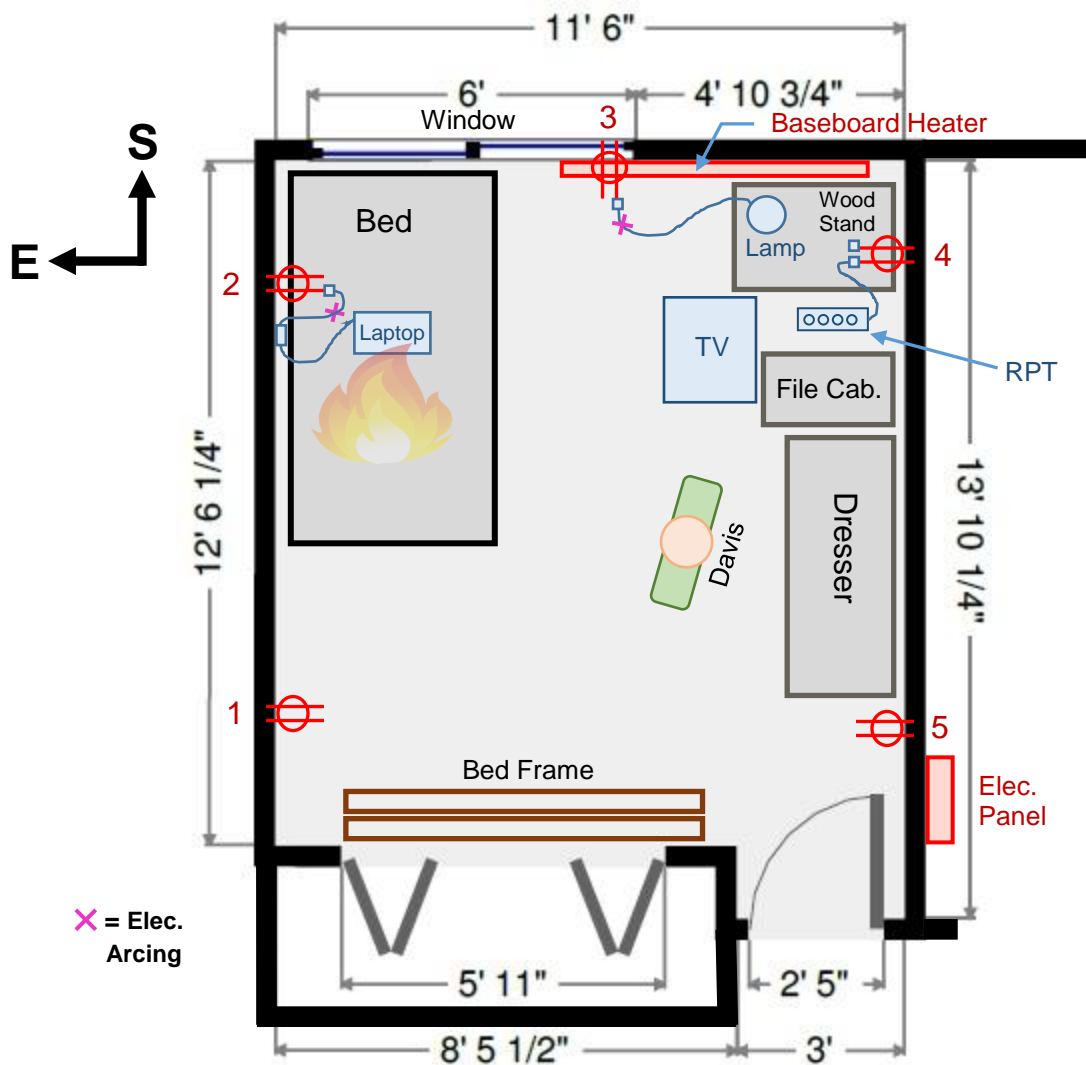
**Figure 3: Apt. E101, Davis Bedroom (SE bedroom) at the time the fire was discovered. Room dimensions accurate, contents not to scale.**

- The southeast bedroom of Apartment E101 sustained the most fire damage. The bed in the southeast corner was consumed by fire. The fire travelled out the east window and extended upward and outward. Fire eventually spread eastward through the roof structure.
